**Dunnville Drinking Water System  
2019 Annual Water Quality Report**

January 1, 2019 – December 31, 2019

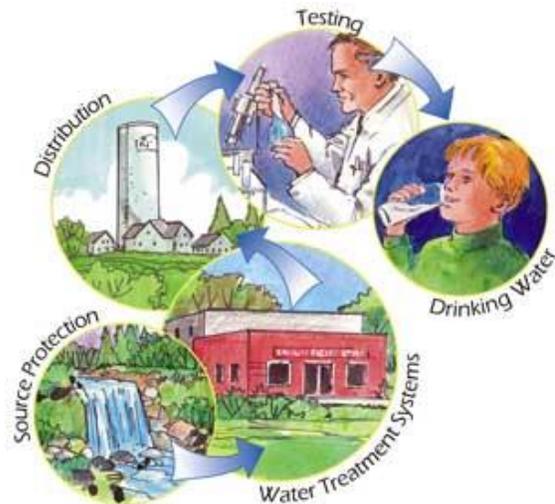
Through the Walkerton Inquiry, Justice O'Connor recommended that drinking water is best protected by taking an approach that uses multiple barriers to prevent contamination from affecting our drinking water. The multi-barrier approach addresses potential threats by ensuring barriers are in place to either eliminate or minimize their impact. This holistic approach recognizes that each barrier may not be able to completely remove a contaminant, but by working together the barriers provide a high-level of protection. Typical barriers include:

- **Source Protection**
  - **Source Protection Plans**
- **Treatment**
  - **Treatment and Disinfection Goals**
- **Distribution System**
  - **Chlorine Residual Maintenance**
- **Monitoring**
  - **Sampling Programs**
- **Emergency Preparedness**
  - **Emergency Plans**

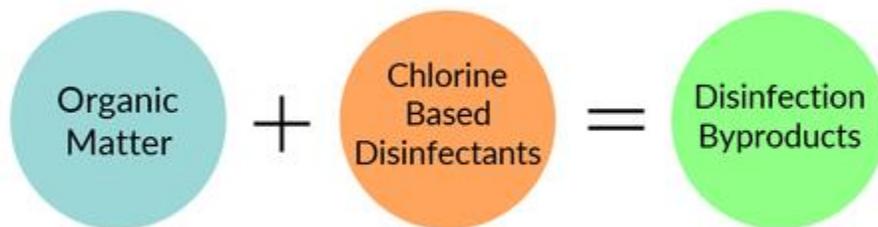
To protect drinking water from pathogens, a disinfectant (usually chlorine) is added to the drinking water. Disinfectants can react with naturally-occurring materials in the water to form disinfection byproducts (DBP), which may pose health risks.

A challenge for water systems is balancing pathogen control and disinfection byproduct formation. It is important to provide protection from pathogens while minimizing health risks from disinfection byproducts. More information on each byproduct is summarized in Table 7.

Haldimand County sample for haloacetic acids (HAA) and trihalomethanes (THM) at the water treatment plant and in the distribution system where there is an elevated potential for the formation of these byproducts. Although a treatment sample is not required by regulation, the sample is used to monitor byproduct formation within the drinking water system.
