## **Dunnville Drinking Water System 2018 Annual Water Quality Report**

January 1, 2018 – December 31, 2018

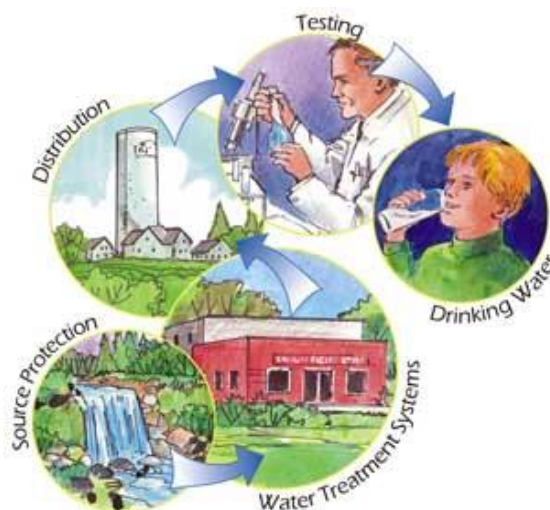
**Figure 2: Responsibilities for Clean, Safe and Reliable Drinking Water**

Haldimand County has adopted the multi-barrier approach in ensuring safe, reliable drinking water. *Figure 2* shows how administration, design, maintenance, and operation work together to establish and maintain multi-barrier protection (US EPA, 1998).

- **Administration:** The administrators or managers of a water treatment system are responsible for providing the resources (budget and staff) and policies (hours of staffing, reporting requirements, training and certification requirements, etc.). Funding may also need to be justified and obtained if the design of a system is inadequate or major upgrades are required. Managers establish and maintain emergency response plans and communication procedures to ensure prompt response to unsafe drinking water.

- **Maintenance:** The system must be maintained in good working order with the key equipment functional at all times. Should a key piece of equipment break down then it should be repaired in a timely manner.

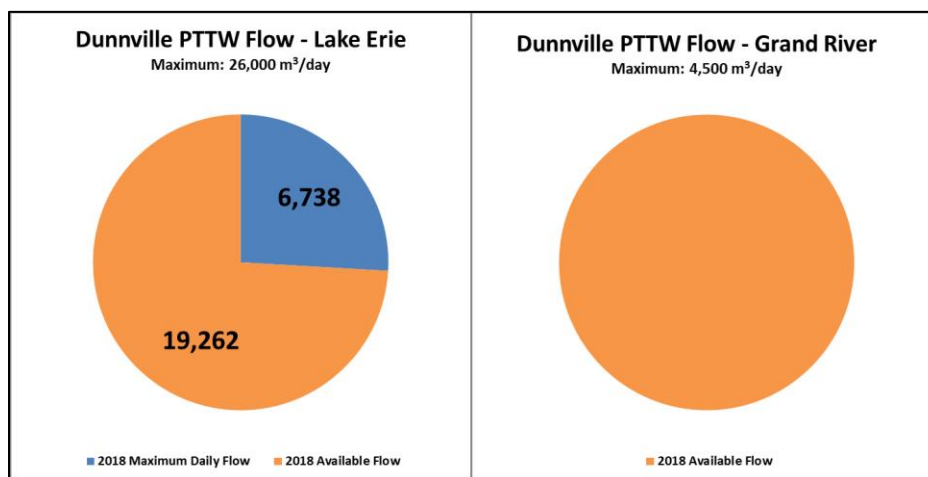
**Figure 3: Dunnville Permit to Take Water (PTTW) Flow Comparisons**

The Dunnville Drinking Water System's raw water source is Lake Erie. A Permit to Take Water (PTTW) specifies the maximum volume of raw water that can be taken from the water source and conveys MECP site-specific regulatory requirements. When comparing the 2018 maximum raw water flow and the permit limits (*Figure 3*), 74.1% of Haldimand County's raw water allotment was available for use. The Grand River water supply was not used in 2018.
