Photos – The Enniskillen Lodge

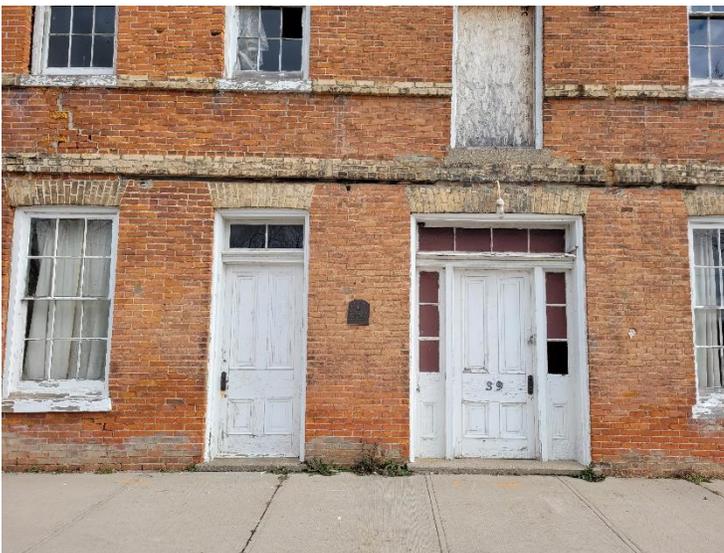
Request to remove panel door (left) and replace with window of the same size and shape of existing windows (six-over-six with mullion bars, including window sill). Brickwork and pointing below new window to be in keeping with existing, e.g. colour, size, material, pattern.

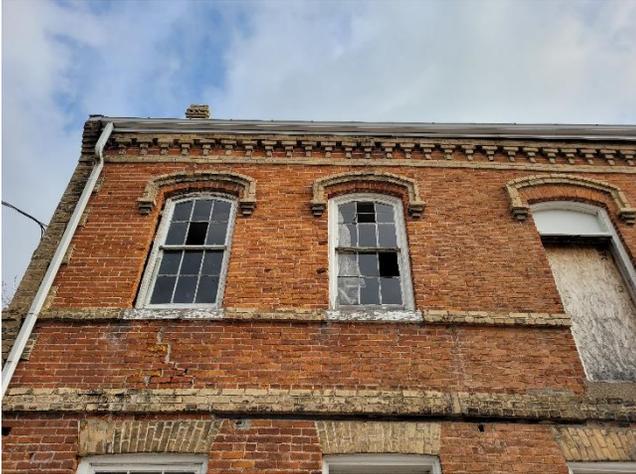
Broken window glass to be repaired; windows being replaced to match original shape and design (six-over-six with mullion bars).

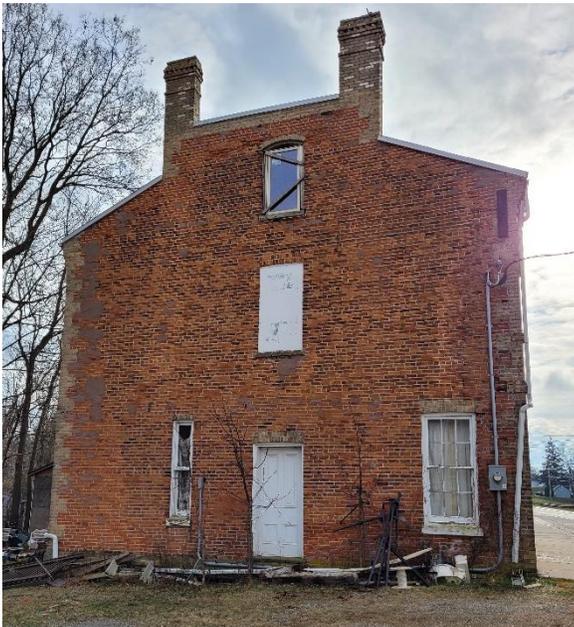
Request to remove entry door and replace with window of same size and shape of existing (six-over-six with mullion bars, including window sill). Brickwork and pointing below new window to be in keeping with existing, e.g. colour, size, material, pattern.

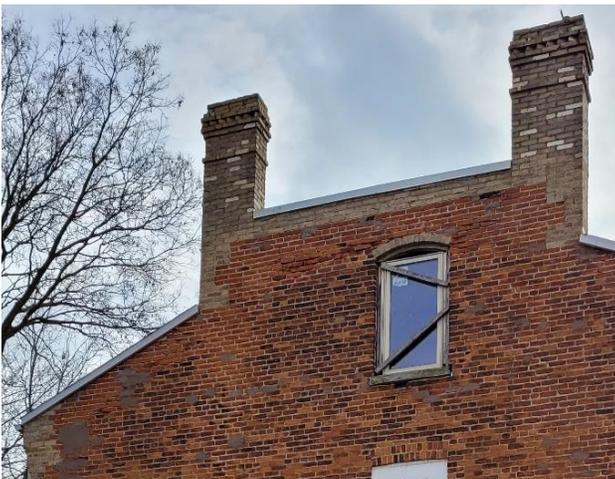
Repointing masonry joints as and where required; should be in based upon the original mortar mix and completed in the original pointing style, either beaded or tuck pointing. Restore or replace loose, cracked, deteriorating or missing brickwork using similar clay brick (size and colour).
